Wolfgang J. Berger

Institut für Verkehrswesen  
(Institute for Transport Studies)  
Universität für Bodenkultur  
Vienna, Austria

## ***EVALUATION OF ACCIDENT BLACK-SPOT REDEVELOPMENT INVESTIGATED AT A SAMPLE OF SITES***

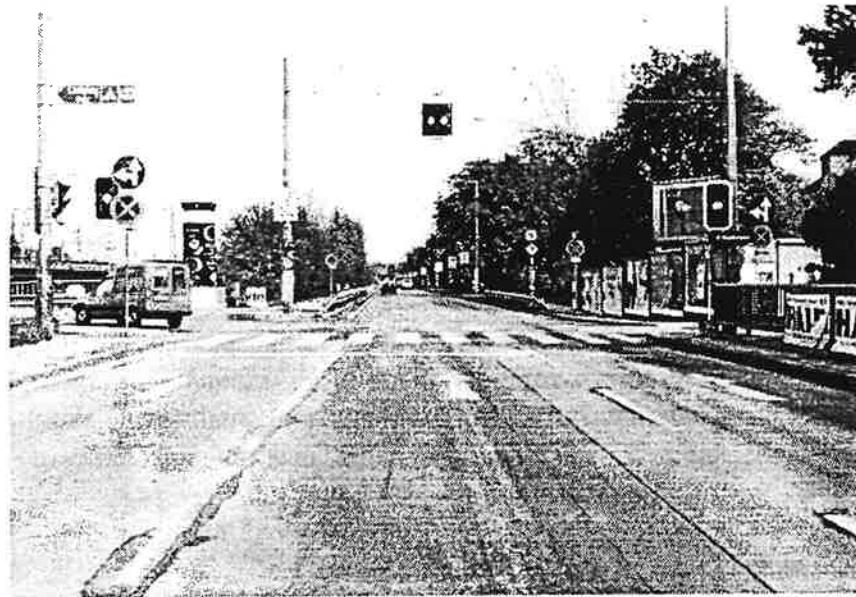
Fig. 1: *Wientalstrasse* when approaching the intersection

On reaching Vienna, the eastbound lanes of motorway A1 (*Westautobahn*) turn into the *Wientalstrasse*, a four lane road reducing to three then two lanes. The speed-limit is 70 km/h. The first crossroads is at the traffic-signal controlled *Stampfergasse/Brauhausebrücke* intersection (Figs. 1 and 2); here a third left-turn lane has been added to the *Wientalstrasse*.

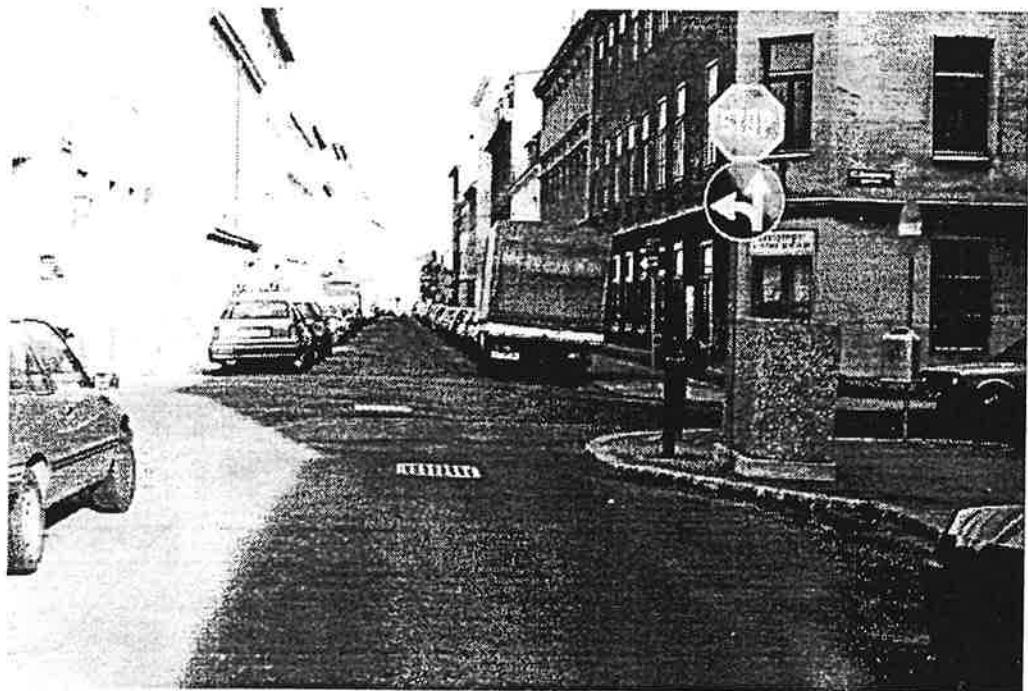
Fig. 5: Intersection *Bergsteiggasse* - *Beheimgasse* with extended pavement

**Measure implemented** (07.1993): The pavement was extended in the important corner of the intersection to improve the sight conditions. The measure does not alter the legal parking conditions, but illegal parking at the junction corner is obviated (Fig. 5).

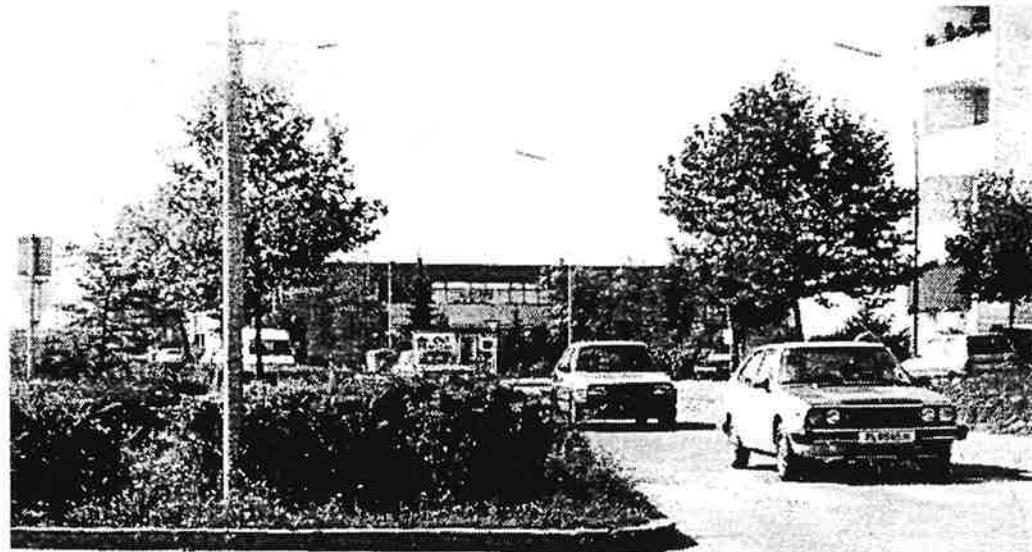
Fig. 9: View from the *Landsbergerstrasse* showing bad sight conditions (original situation)

Both *Josefstrasse* and *Landsbergerstrasse* are two-way roads in a residential area near the centre of *St.Pölten* (the capital of Lower Austria, with a population of about 50 000). The crossroads was a large junction with traffic islands and separate lanes for the right-turning traffic. The whole situation was very confusing for drivers crossing (Fig. 9). Traffic in *Josefstrasse* took precedence over traffic in *Landsbergerstrasse* (give-way signs).

**Presumed main accident causes:** Drivers in the *Landsbergerstrasse* did not recognize that they have to give way to traffic in *Josefstrasse*, and entered the intersection without slowing down. Other drivers observed the traffic in the *Josefstrasse*, but missed or saw too late the approaching vehicles.
