CONFLICT STUDIES AT TWO  
JUNCTIONS IN AUSTRIA

The summary report of the  
Finnish and the Swedish teams

Research report 515

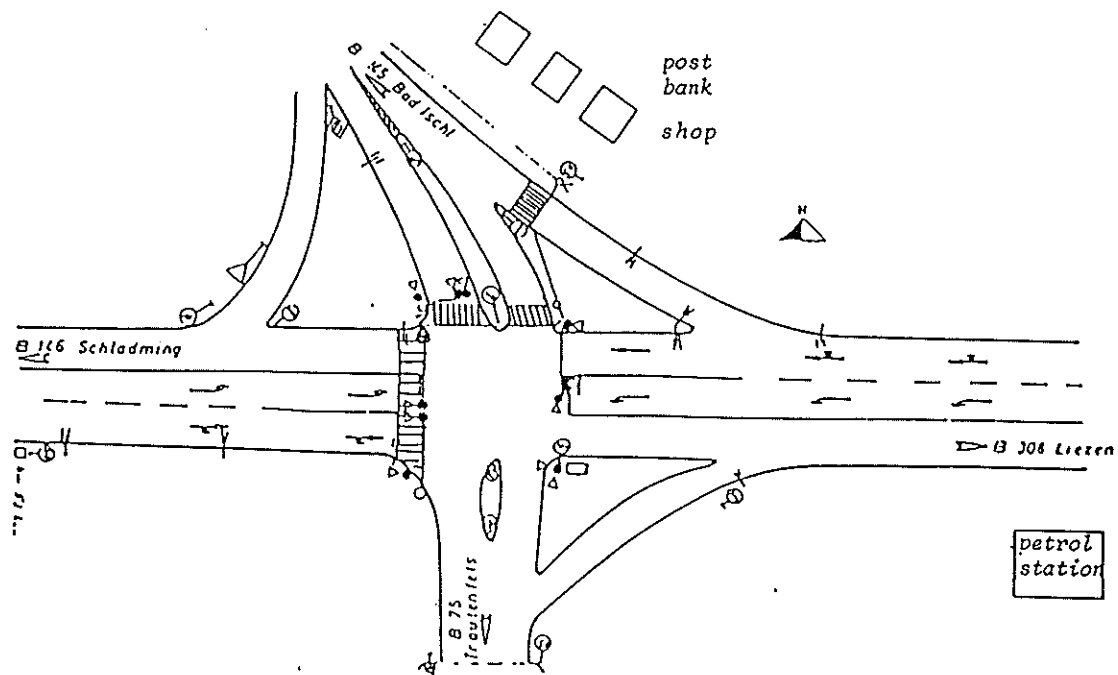
Figure 1. The Trautenfels junction during the before study.

- The intersecting roads are B146/308/B145,75 (Schladming - Liezen)
- Signal controlled, rural junction
- Speed limit: 50 km/h
- Separated right turning lanes in three approaches (non-signalized)
- Petrol station, grocery store, post and bank in connection to the junction
- Cycle time: 100 seconds
- Blinking green at the end of the green phase
- Large proportion of heavy vehicles (20 %)
- Few pedestrians and bicyclists
- Good sight distances

In figure 1 is a chart of the Trautenfels junction. The description and the chart are according to the before situation.

The countermeasures made in Trautenfels after the before studies in May are:

- Improvement of signposting by installing larger guideposts on both sides of the roads from all 4 directions /2/.
- 70 km/h speed limit sign 100 m in front of the junction on both sides of the road from all 4 directions /2/.
- Announcement of the traffic light 250 m in front of the junction on both sides of the road from all 4 directions by eye catching 150 cm - edge- traffic signs /2/.
- The signs from all 4 directions announcing the traffic light 250 m in front of the junction should be equipped with a blinking light in the yellow field of the symbolized traffic light /2/.
- On the way going from Trautenfels to Bad Ischl there was a line painted on the road just before the ramp coming from the direction of Liezen.

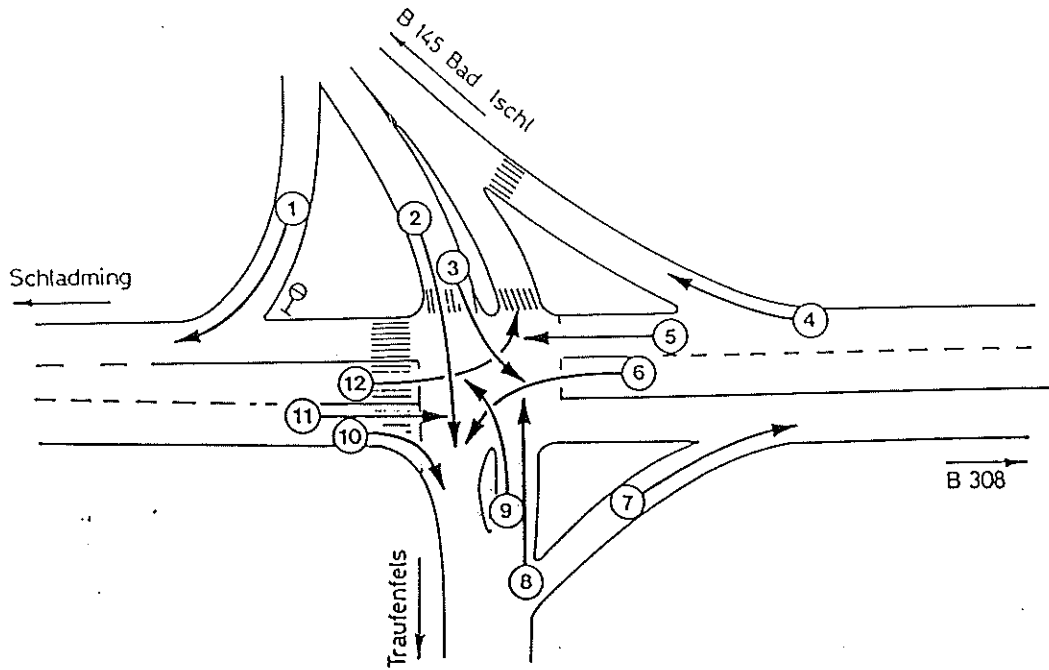
Figure 2. The numbrering of traffic flows in the Trautenfels junction.

The conflict chart presenting the locations and the types of the conflicts during the before and the after observations is in appendix 1. The increase in conflicts was due to the increase of traffic volumes. The numbering of traffic flows in the Trautenfels junction is presented in figure 2.

The number of traffic flow	Traffic volumes (4-wheeled vehicles)	
	Before	After
1	290	410
2	520	480
3	1340	1800
4	1070	1820
5	2140	5150
6	590	820
7	510	810
8	460	420
9	5	40
10	20	20
11	1880	3540
12	240	420
Total	9065	15730

In the main directions during the after observations the traffic volumes were about twice as high as during the before observations (flows number 5 and 11). Most of the traffic volumes had increased clearly. This explains the increase of conflicts in the junction.

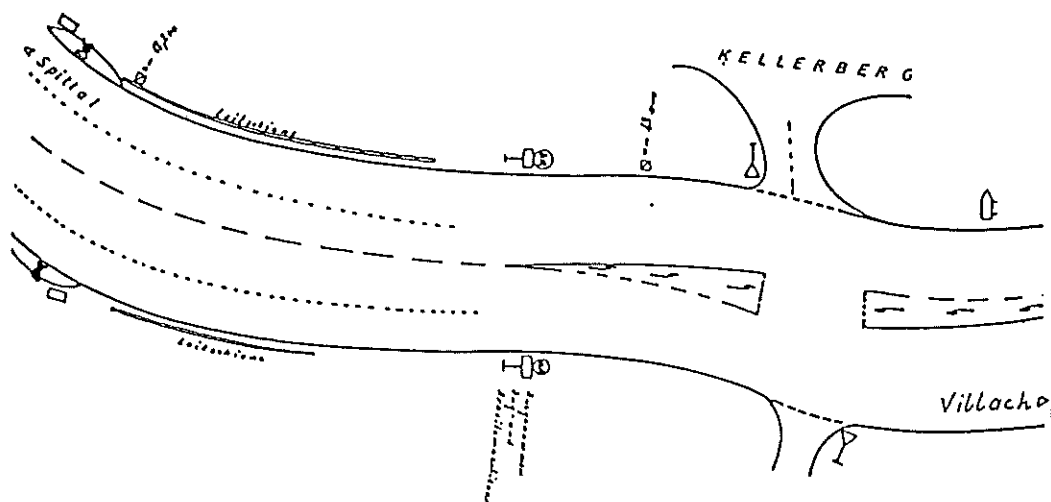
Figure 3. The Kellerberg junction during the before study.

- Rural conditions (B100, Spittal - Villach)
- The junction is the "main entrance" to the village (88 inhabitants)
- Speed limit: 100 km/h
- Traffic volumes much higher on the main road
- Fairly large proportion of heavy vehicles (11 % on a count of the Swedish team, friday afternoon)
- Both horizontal and vertical curves in connection to the junction produce poor sight distances
- Construction of a new road in the vicinity produces some occasional traffic
- Overtaking lane north of the junction, both directions
- "No" pedestrians or cyclists
- Overtaking prohibited through the junction (on the main road)

In figure 3 is a chart of the Kellerberg junction. The description and the chart are made according to the before situation.

The countermeasures made in Kellerberg after the before studies in May are:

- Road markings which draw the drivers' attention and make them aware in time of the end of the possibility for overtaking before the junction area (arrows on the left lane pointing to the right lane) /2/.
- Traffic signs at the right side of the road combined with the request "allow others to move into your lane in front of your car" /2/.
- Shortening of the left turning lane and installation of a longer painted traffic island before the left turning lane /2/.
- The leg leading to the motor way construction site had been lined with a kerb on both sides after the before studies.

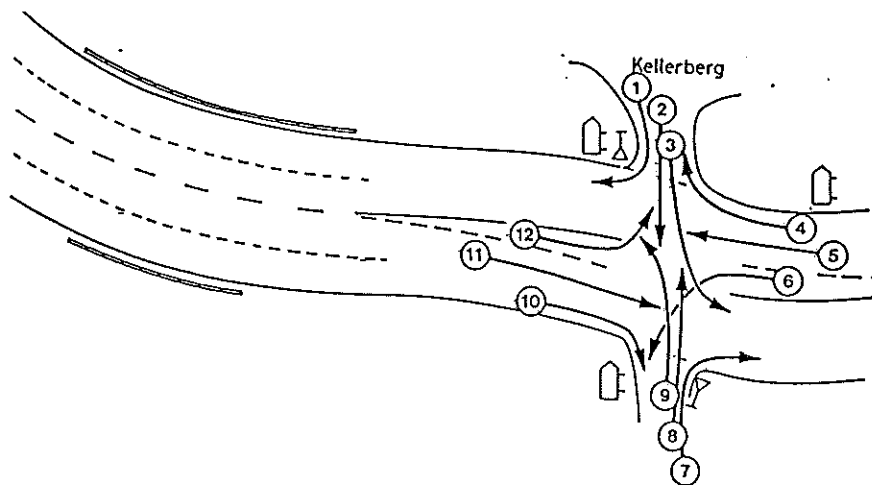
Figure 4. The numbering of traffic flows in the Kellerberg junction.

The conflict chart presenting the locations and the types of the conflicts during the before and after observations is in appendix 3. The number of conflicts remained the same. The numbering of traffic flows in the Kellerberg junction is presented in figure 4.

The number of traffic flow	Traffic volumes (4-wheeled vehicles)	
	Before (13 h)	After (14 h)
1	15	63
2	6	4
3	85	113
4	84	156
5	4740	9350
6	7	13
7	13	11
8	9	6
9	9	9
10	8	15
11	5350	7100
12	11	39
Total	10337	16879

In the main directions (flows number 5 and 11) the traffic volumes had increased clearly. There were also clearly more vehicles coming from the village of Kellerberg during the after observations. Although there were more traffic during the after observations the amount of conflicts remained the same. The most common type of conflicts was during the both observation periods the right angle conflict between the flows number 3 and 11.

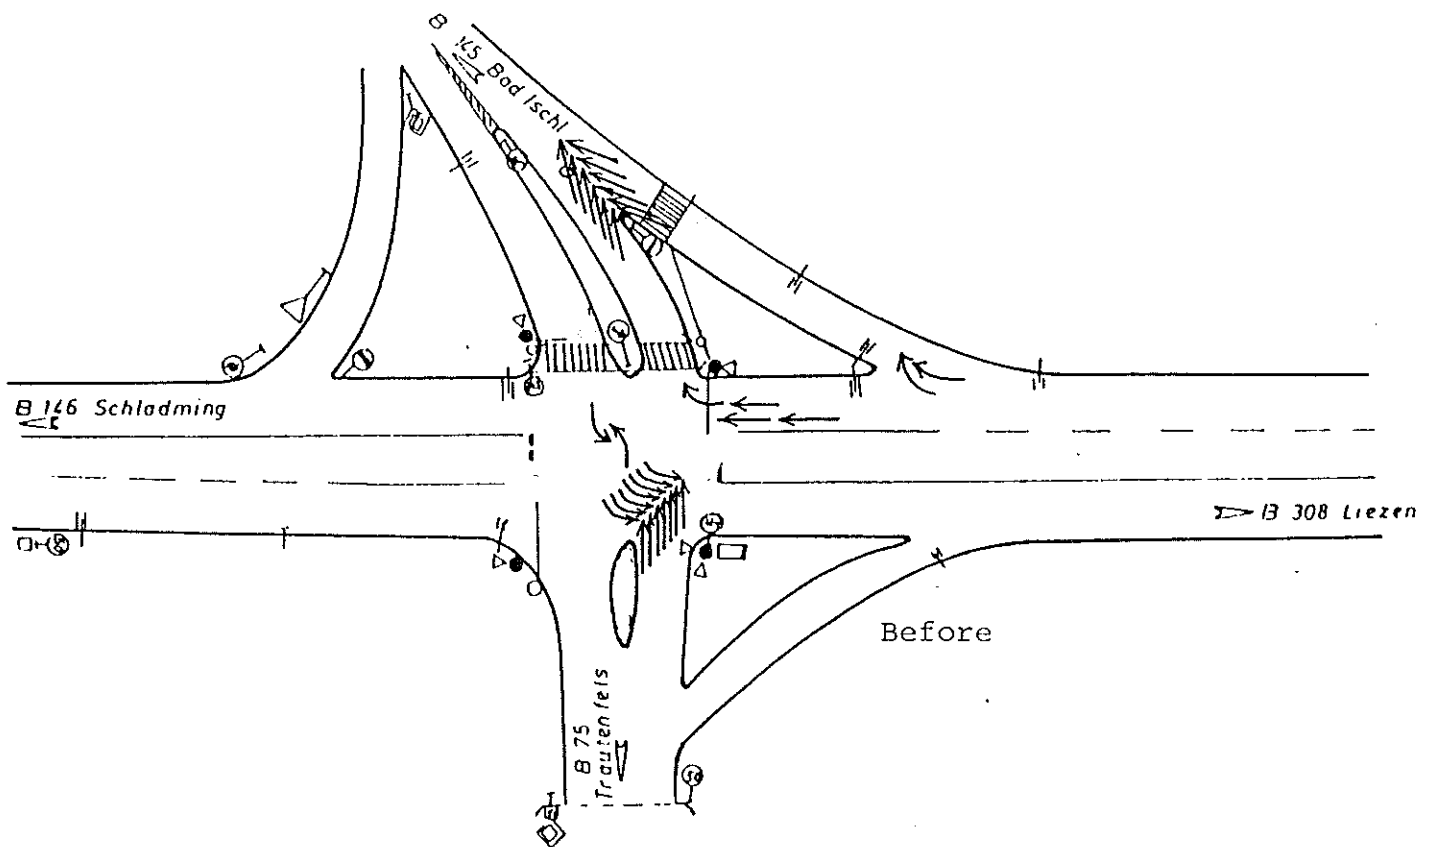
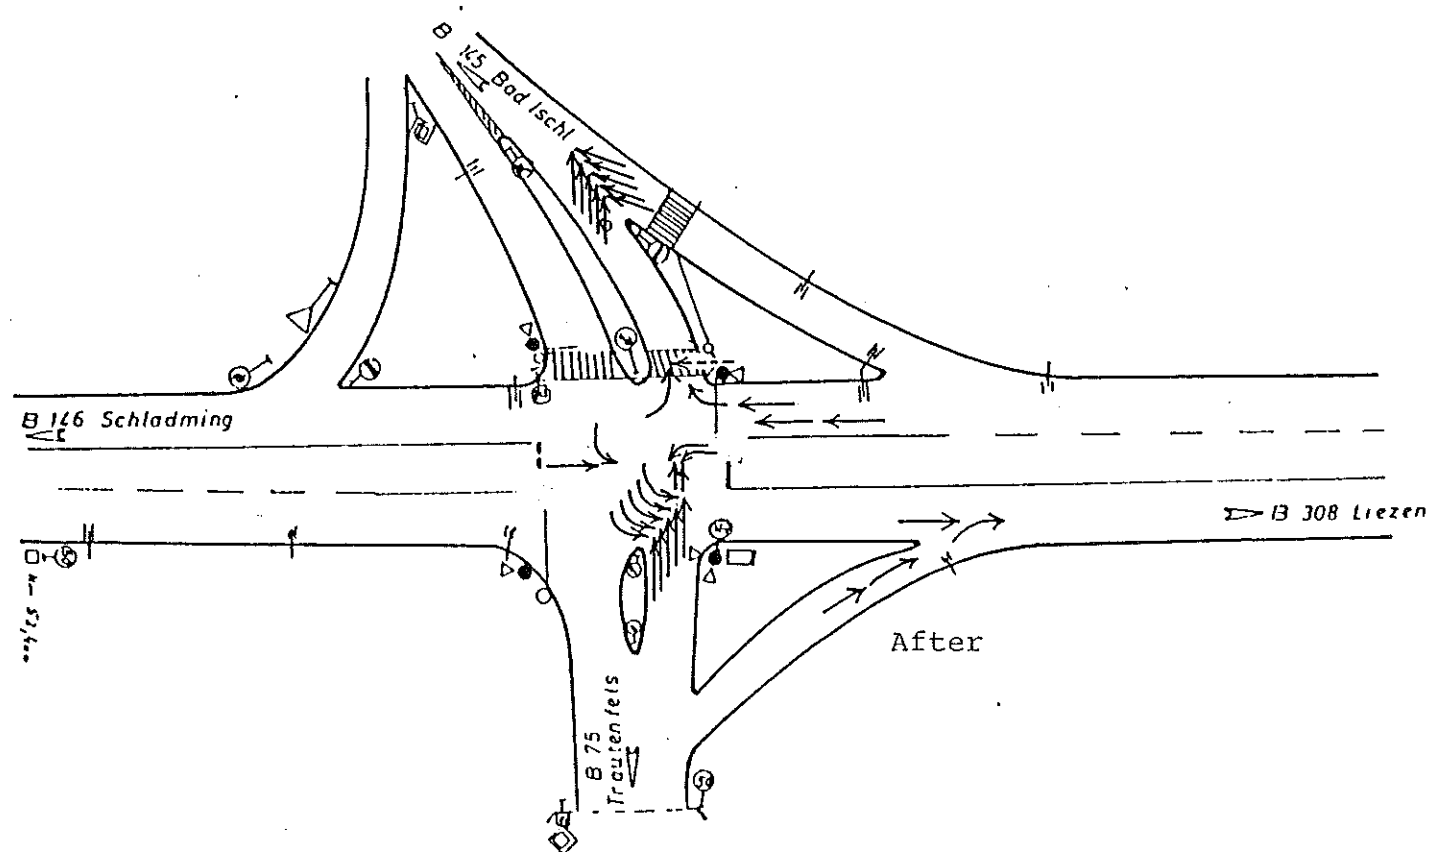
The conflict studies indicate that no improvement of traffic safety has been obtained. The clusters of conflicts seem to be the same in the after study as before. The majority of conflicts occur between vehicles. Bicyclists and pedestrians are quite few. The increased traffic volumes on the main road do not influence the results as these flows are not involved in any conflicts. One obvious problem that is not solved by the countermeasures is the weaving conflicts between right turners from east (Liesen) on the ramp and straight on going cars from Trautenfels. The priority rules

The conflict charts of the before and after studies are in appendix 2.

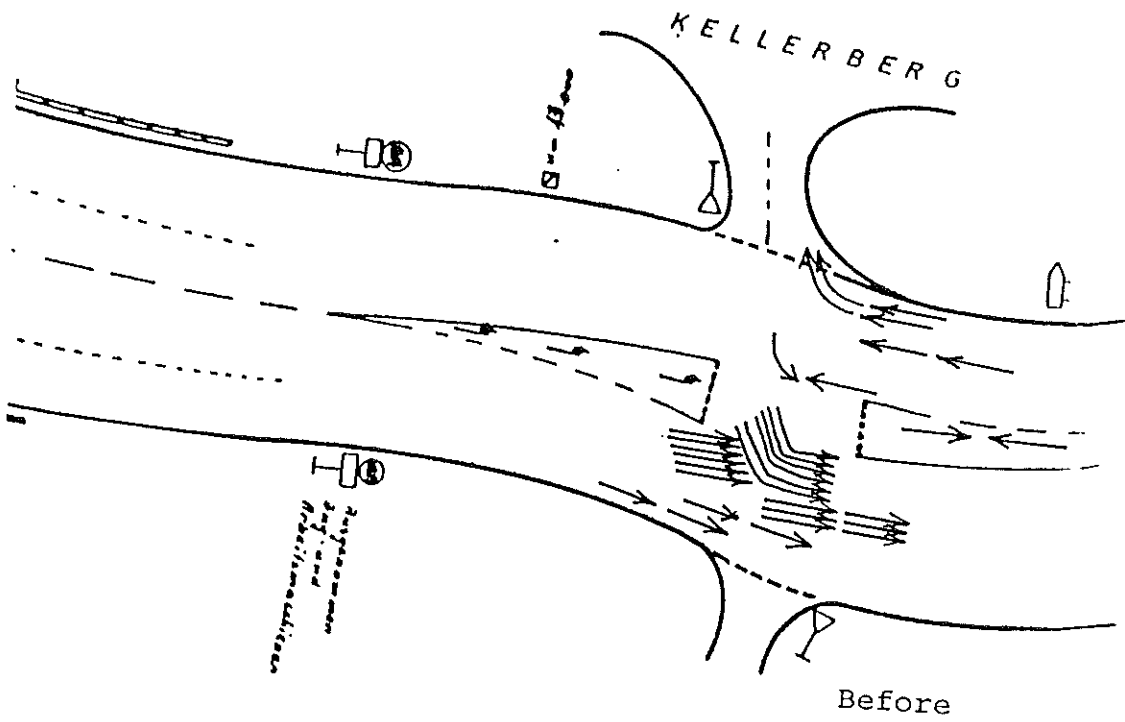
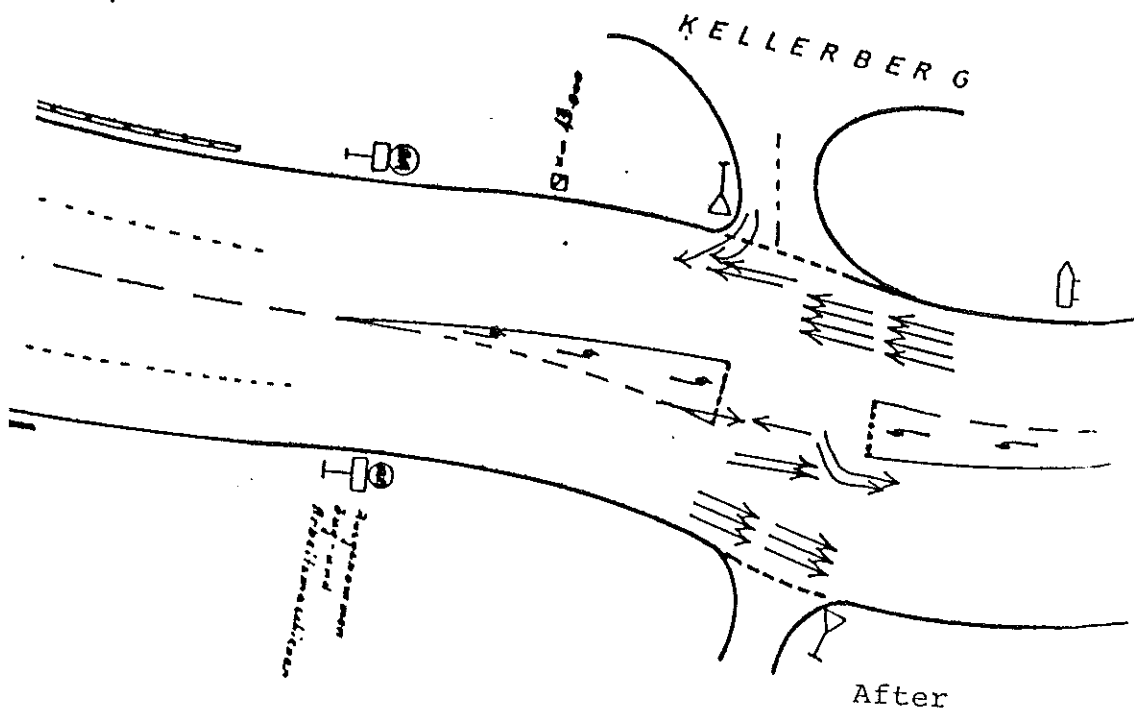
The conflict charts of the before and after studies are in appendix 4.
