IMPLEMENTATION OF INFRASTRUCTURE MEASURES FOR IMPROVING POWERED TWO-WHEELERS SAFETY ON SLOVENIAN NATIONAL ROAD NETWORK

ABSTRACT

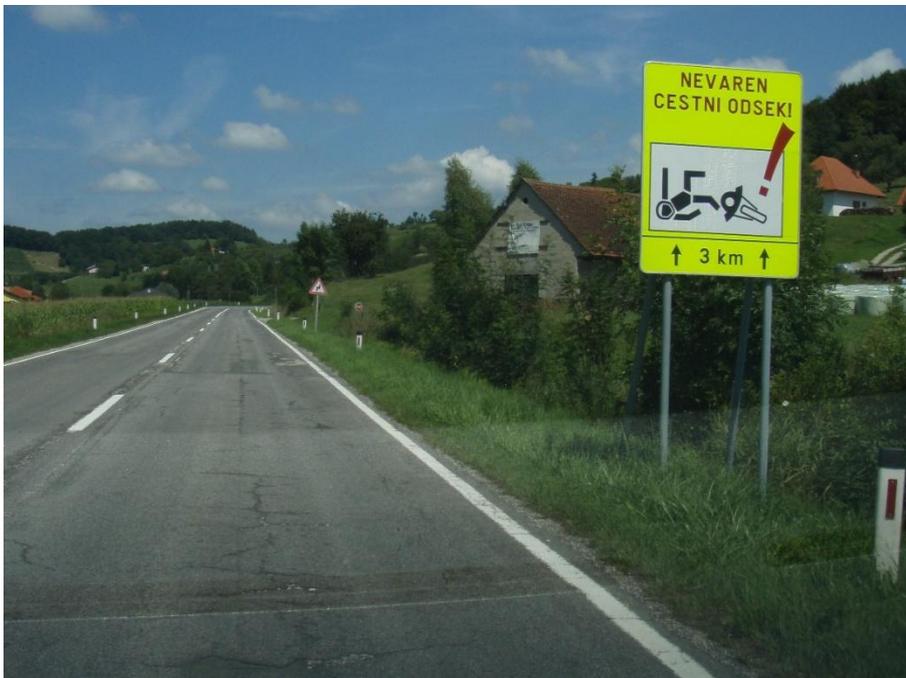
Figure 1: The additional warning signs

In Slovenia, the additional warning signs for PTW riders, in similar form as ours additional warning signs for "dangerous road sections / intersections" ("black spots"), are in used since 2006. In our case, those additional warning signs look more like traffic signs (Fig. 1). We could say that this kind of warning signs should be classified in group of informational / notifying traffic signs.

Additional warning signs for PTW riders usually contain information about length of dangerous section, for example of 3000 meters. Since those sections are relatively long (between 1500 m and 10 000 m) we could put legally question about "validity" of these signs through entire section (since the riders can easy "forget" the warning sign while riding alongside the road).

The additional warning signs for PTW riders should be installed on those road sections, where the large proportion of PTW riders in traffic flow occurred. Especially, another attention should be given to "tourists PTW routes" where during touristic season enlarged proportion of PTW riders from abroad often happened.

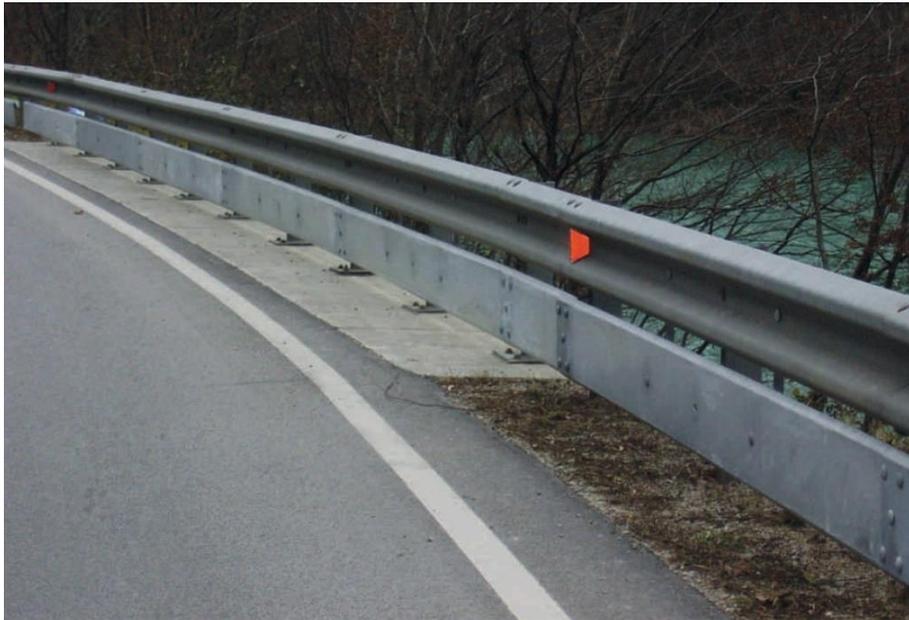
Figure 2: The additional lamellas at existing safety barrier

The general principle of a PTW-friendly safety barrier is to protect the fallen PTW rider from jutting support posts. In our case, additional lamellas were placed onto some existing safety barriers (Figure 2).

Installation of additional lamellas is an immediate measure, particularly at the location of road curves, where "classic" steel barriers are already installed. The installation of additional lamellas were taken on the locations where (i) in the past more accidents with hard injured PTW riders occurred and (ii) extremely high proportion of PTW riders at traffic flow occurred. Those road sections represented curved road alignments, mostly in hilly area. Additional lamella was installed along entire length of existing safety barrier at the particular section / curve.

Combination of both safety measures represents additional lamellas at safety barriers on road sections with additional warning signs for PTW riders. That means road sections equipped with additional warning signs, on curves inside this section additional lamellas were installed on existing safety barriers.
